Manhole Inspection Summary

Manhole # S35AA_001MH

Location Address: **14 READ ST**

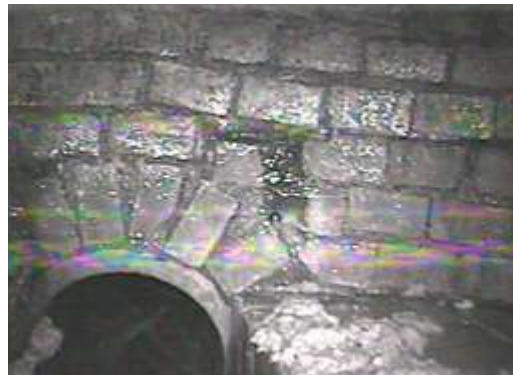
Defect 1

INFILTRATION SEAL- WEEPER

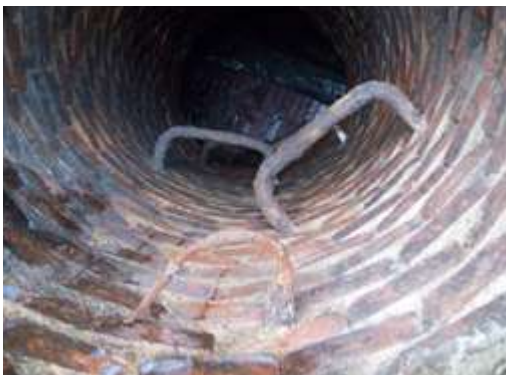
Defect 2

Count: **9** Missing: **1** ☒ **Corroded**

CORRODED STEPS

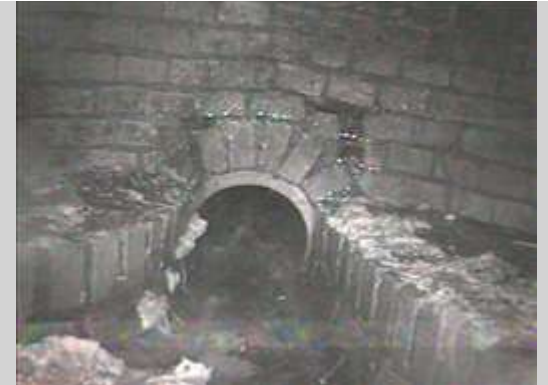
12 O'Clock Outflow

12 in. Circular Gravity Sewer
Pipe Out @ 12 O'Clock

Pipe Height: (in.) Direct
Pipe Material: **Clay** ☐ Pipe Lined
Invert Depth: **13.09** (ft.) Flow Characteristics: **Fast**
Deposits: ☒ None ☐ Mud ☐ ~~Gravy~~ ☐ Debris ☐ Grease
Silt Depth: (in.) Deposits Extent:
Infiltration: **None** Pipe Seal Cond: **Sound**

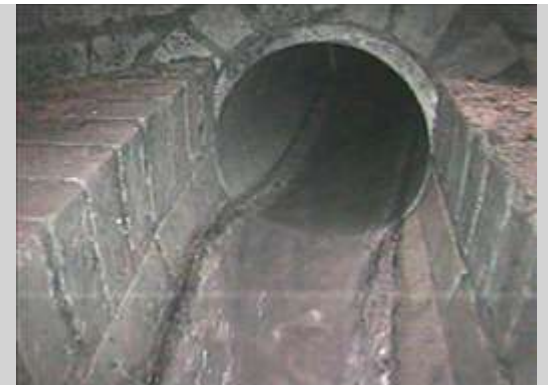
6 O'Clock Inflow

10 in. Circular Gravity Sewer
Pipe In @ 6 O'Clock

Pipe Height: **12** (in.) Rod and Bar (Angled)
Pipe Material: **Clay** ☐ Pipe Lined
Invert Depth: **13.66** (ft.) Flow Characteristics: **Fast**
Deposits: ☒ None ☐ Mud ☐ ~~Gravy~~ ☐ Debris ☐ Grease
Silt Depth: (in.) Deposits Extent:
Infiltration: **None** Pipe Seal Cond: **Sound**

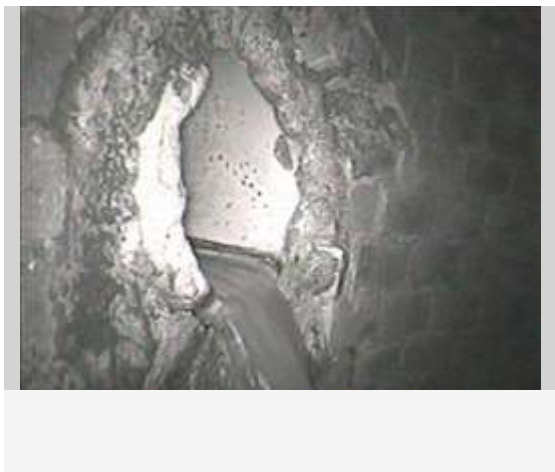
9 O'Clock Inflow

8 in. Circular Gravity Sewer
Pipe In @ 9 O'Clock

Pipe Height: (in.) Direct
Pipe Material: **Clay** ☐ Pipe Lined
Invert Depth: **9.07** (ft.) Flow Characteristics: **Fast**
Deposits: ☐ None ☐ Mud ☒ **Sludge** ☒ **Debris** ☒ **Grease**
Silt Depth: **8** (in.) Deposits Extent: **Heavy**
Infiltration: **None** Pipe Seal Cond: **Sound**

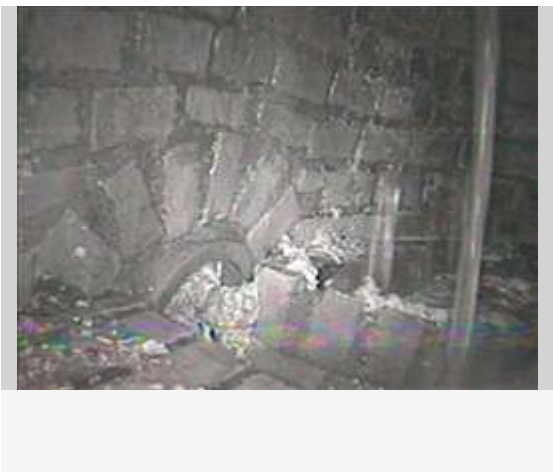
Drop In @ 9 O'Clock

Drop: Outside	Direct
Angled:	Reading: (ft.)
	Inv Depth: 12.96 (ft.)
Drop Condition: Clogged	
Connects To: Manhole	
<input type="checkbox"/> Possible Illicit Connection
